Manhole Inspection Summary

Manhole # S21M__022MH

Location Address: **1836 eagle st**

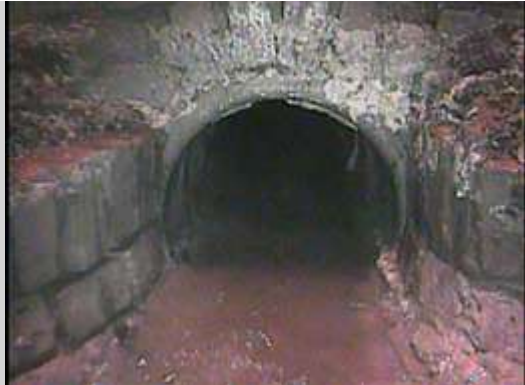
12 O'Clock Outflow

12 in. Circular Gravity Sewer
Pipe Out @ 12 O'Clock

Pipe Height: **12** (in.) Rod and Bar (Angled)
Pipe Material: **Clay** ☐ Pipe Lined
Invert Depth: **11.90** (ft.) Flow Characteristics: **Slow**
Deposits: ☒ None ☐ Mud ☐ Sludge ☐ Debris ☐ Grease
Silt Depth: **0** (in.) Deposits Extent:
Infiltration: **None** Pipe Seal Cond: **Sound**

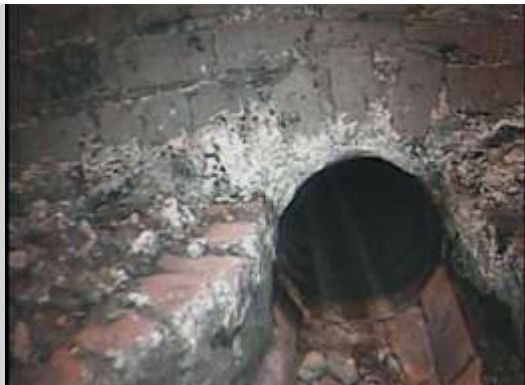
3 O'Clock Inflow

8 in. Circular Gravity Sewer
Pipe In @ 3 O'Clock

Pipe Height: **8.4** (in.) Rod and Bar (Angled)
Pipe Material: **Clay** ☐ Pipe Lined
Invert Depth: **11.50** (ft.) Flow Characteristics: **Slow**
Deposits: ☒ None ☐ Mud ☐ Sludge ☐ Debris ☐ Grease
Silt Depth: **0** (in.) Deposits Extent:
Infiltration: **None** Pipe Seal Cond: **Sound**

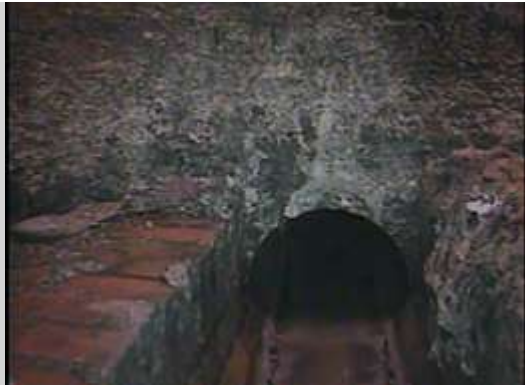
6 O'Clock Inflow

10 in. Circular Gravity Sewer

Pipe In @ 6 O'Clock

Pipe Height: **10.8** (in.) Rod and Bar (Angled)

Pipe Material: **Clay** ☐ Pipe Lined

Infiltration: **None** Pipe Seal Cond: **Sound**
